# Geophysical Post-construction Integrity Assessment of the Subsurface Conditions of a Church Auditorium in Ado-Ekiti, Southwestern Nigeria

\*<sup>1</sup>Akinola B. Eluwole, <sup>1</sup>Temitope E. Olasupo, <sup>2</sup>Idowu O. Idowu, <sup>1</sup>Kamal O. Ibrahim and <sup>1</sup>Kolawole Ajele

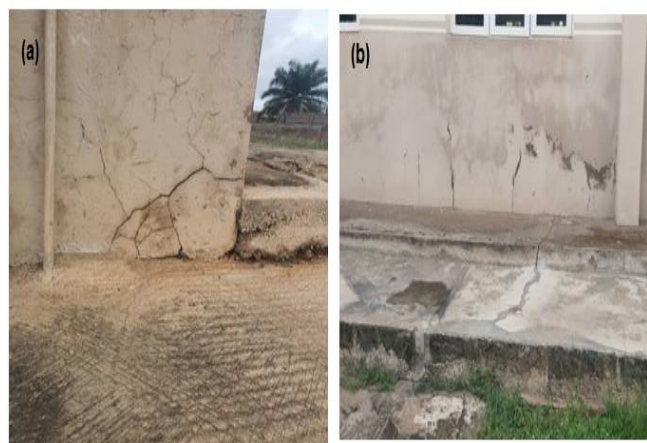
Plate 1. Symptoms of Distress observed on the building. (a) Basal Mesh of Cracks (b) Rising damp, blistered paint and flaked plaster.

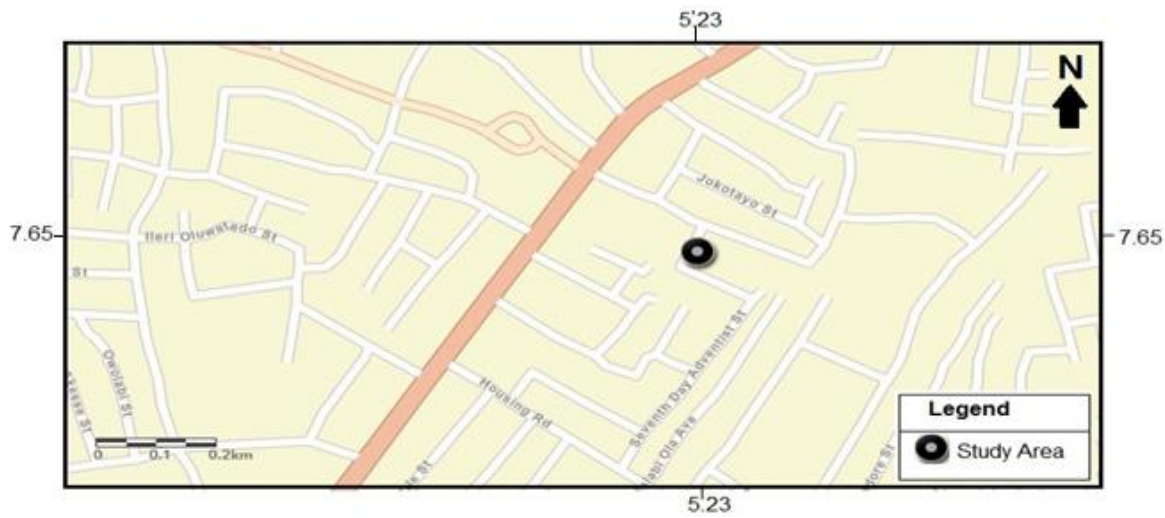
Fig. 1: Location map of the study area

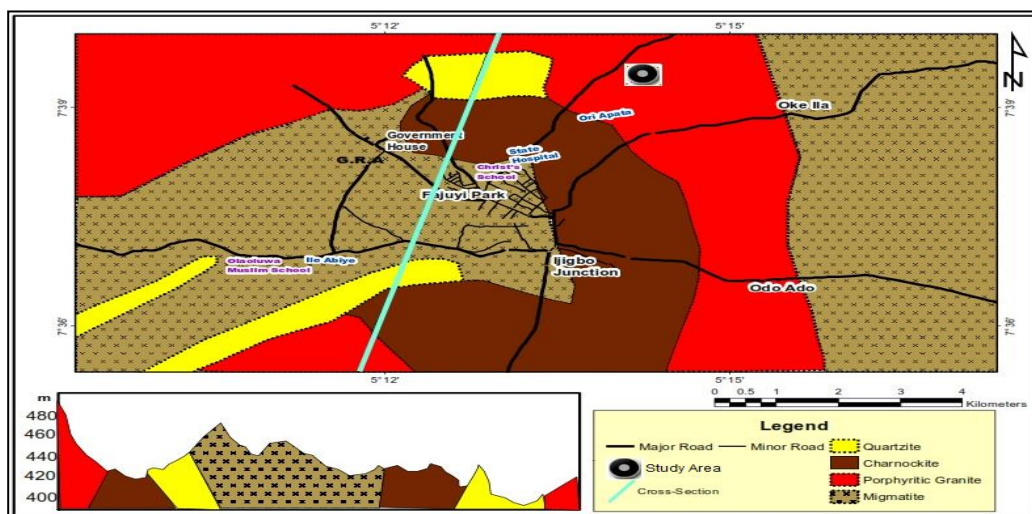
Fig. 2: Geological map of the area around the study area

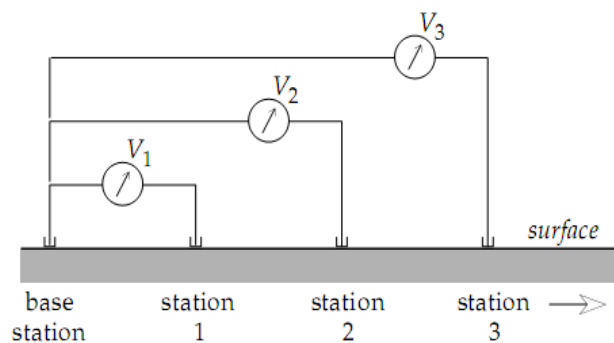
Fig. 3: The Total Field Array of the SP Method

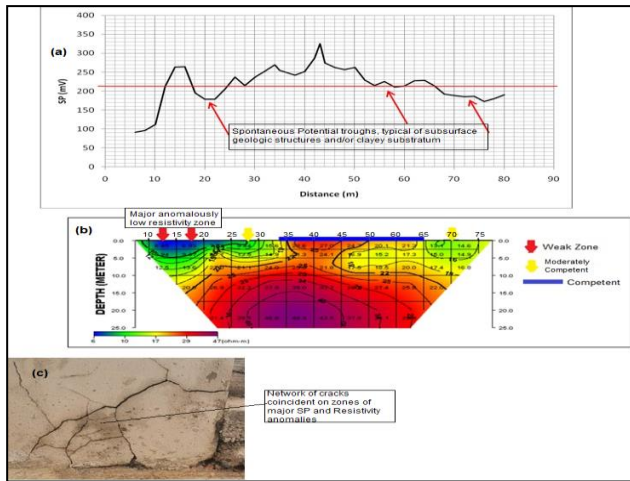
Fig. 6: Results from Traverse 1. (a) Spontaneous Potential Profile (b) 2-D Subsurface Electrical Resistivity Image (c) Network of cracks on the rear corner of the building.

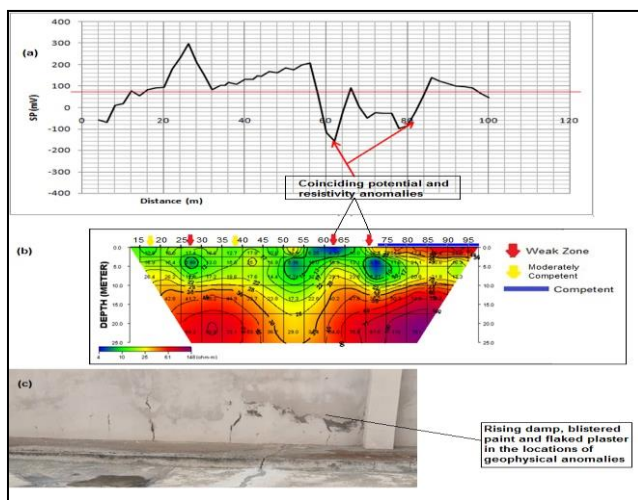
Fig. 7: Results from Traverse 2. (a) Spontaneous Potential Profile (b) 2-D Subsurface Electrical Resistivity Image (c) A portion of the building manifesting symptoms of distress.

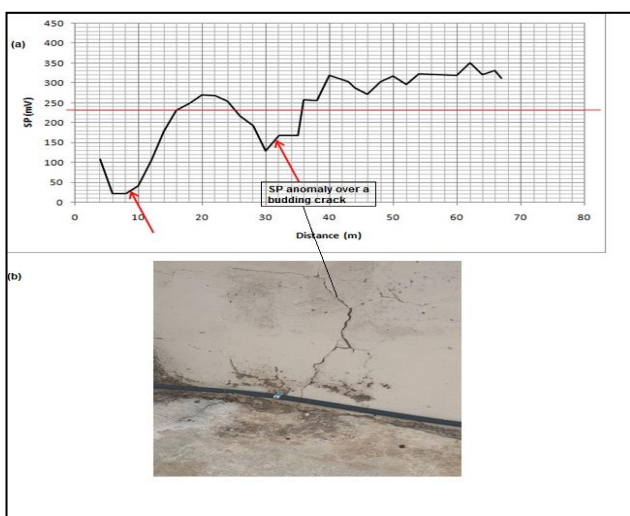
Fig. 8: Results from Traverse 3 (a) Spontaneous Potential Profile (b) 2-D Subsurface Electrical Resistivity Image (c) A budding crack
